# Hydrilla in the Cayuga Inlet

## August 2011-2020

Roxanna Johnston, Watershed Coordinator-Lab

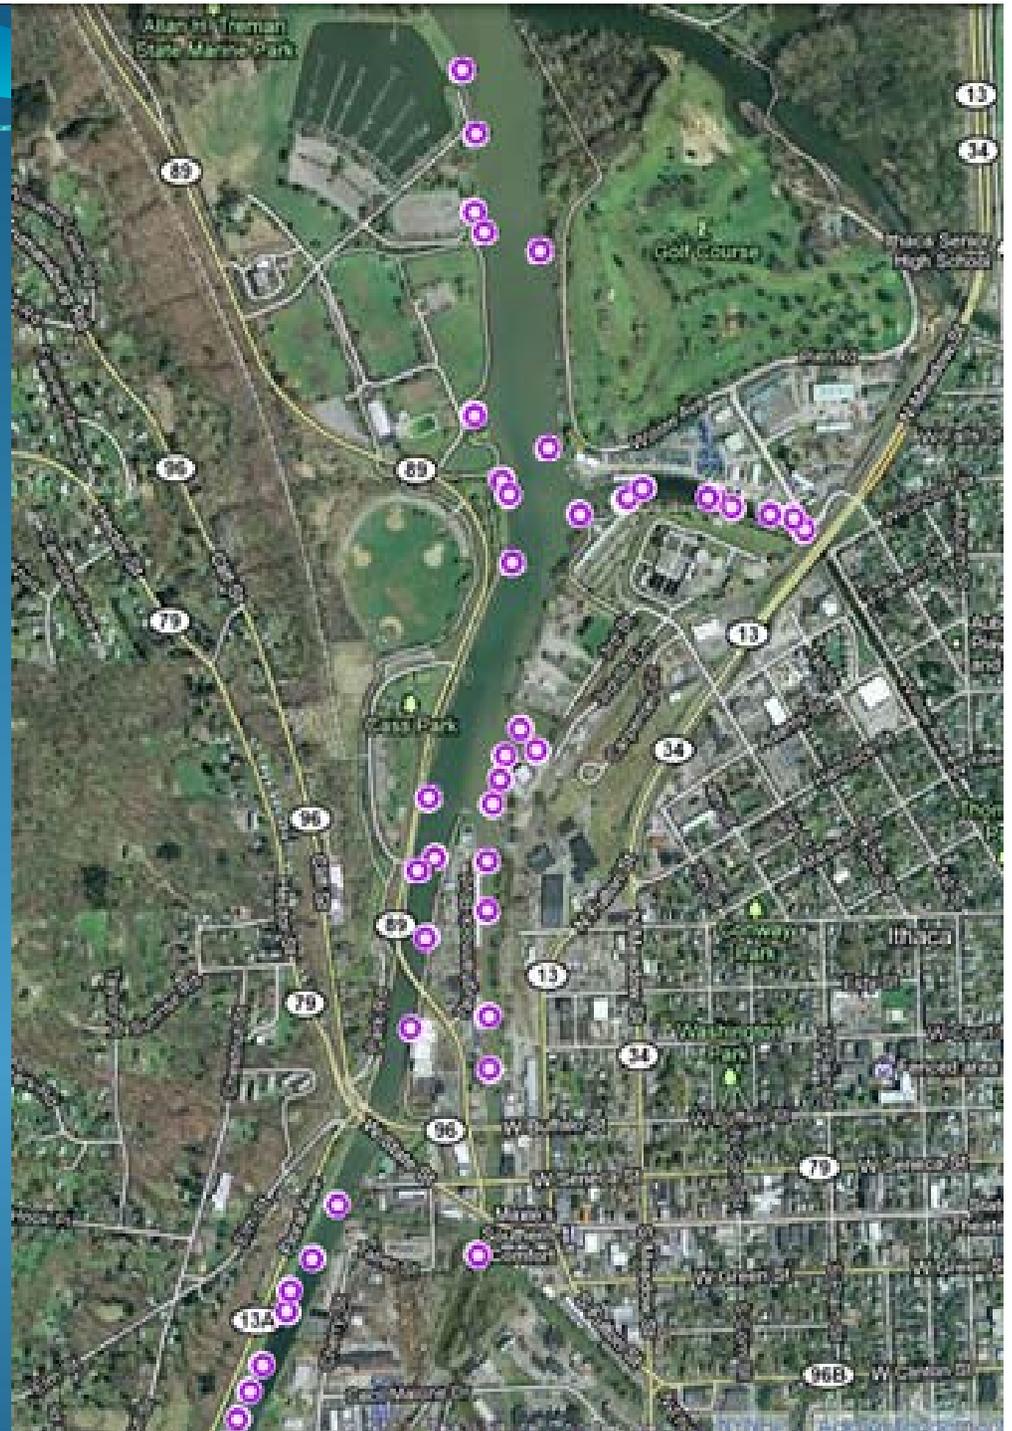
# Fall 2011 Surveys

## Dense populations:

- Farmer's Market docks
- Cascadilla Creek
- Dragon Boat launch/Cass Park
- Cornell University Boathouse

Rooted fragments throughout inlet channel

Small fragments un-rooted to bottom but found on bottom at entrance to lake.

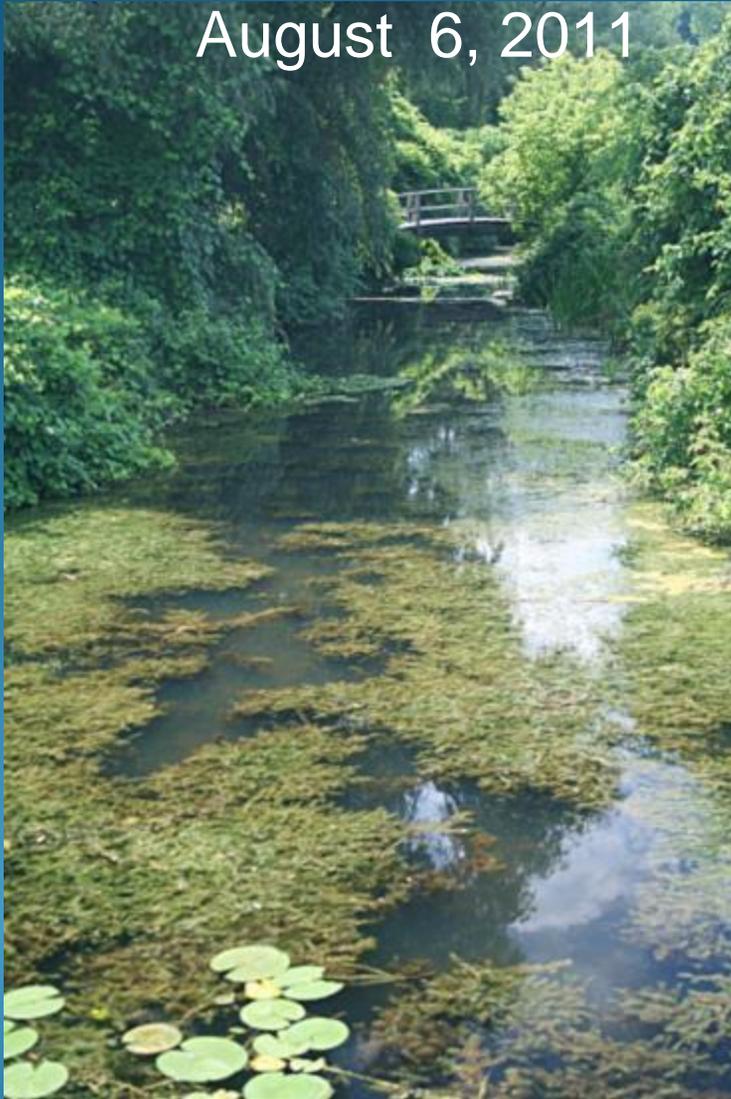
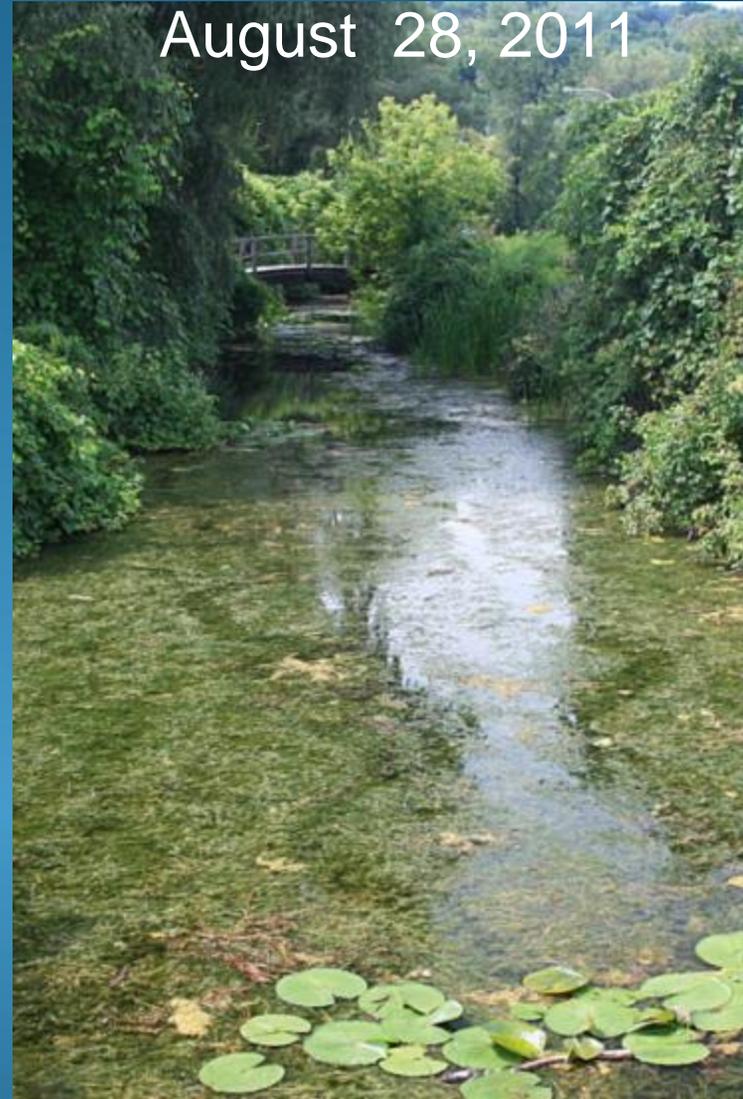
# Rate of Growth in Linderman Creek

August 6, 2011

August 28, 2011

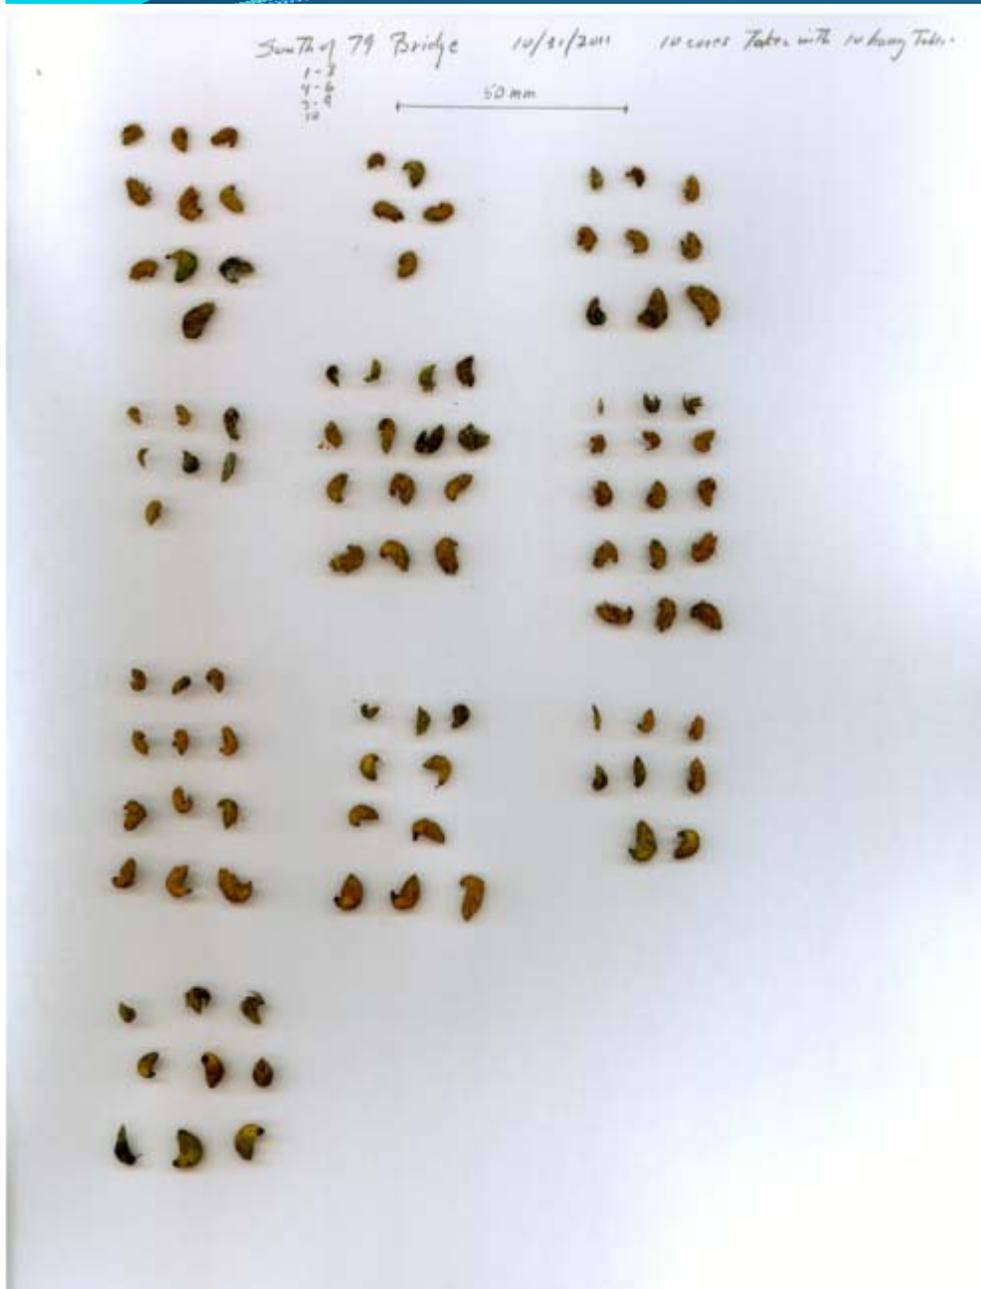
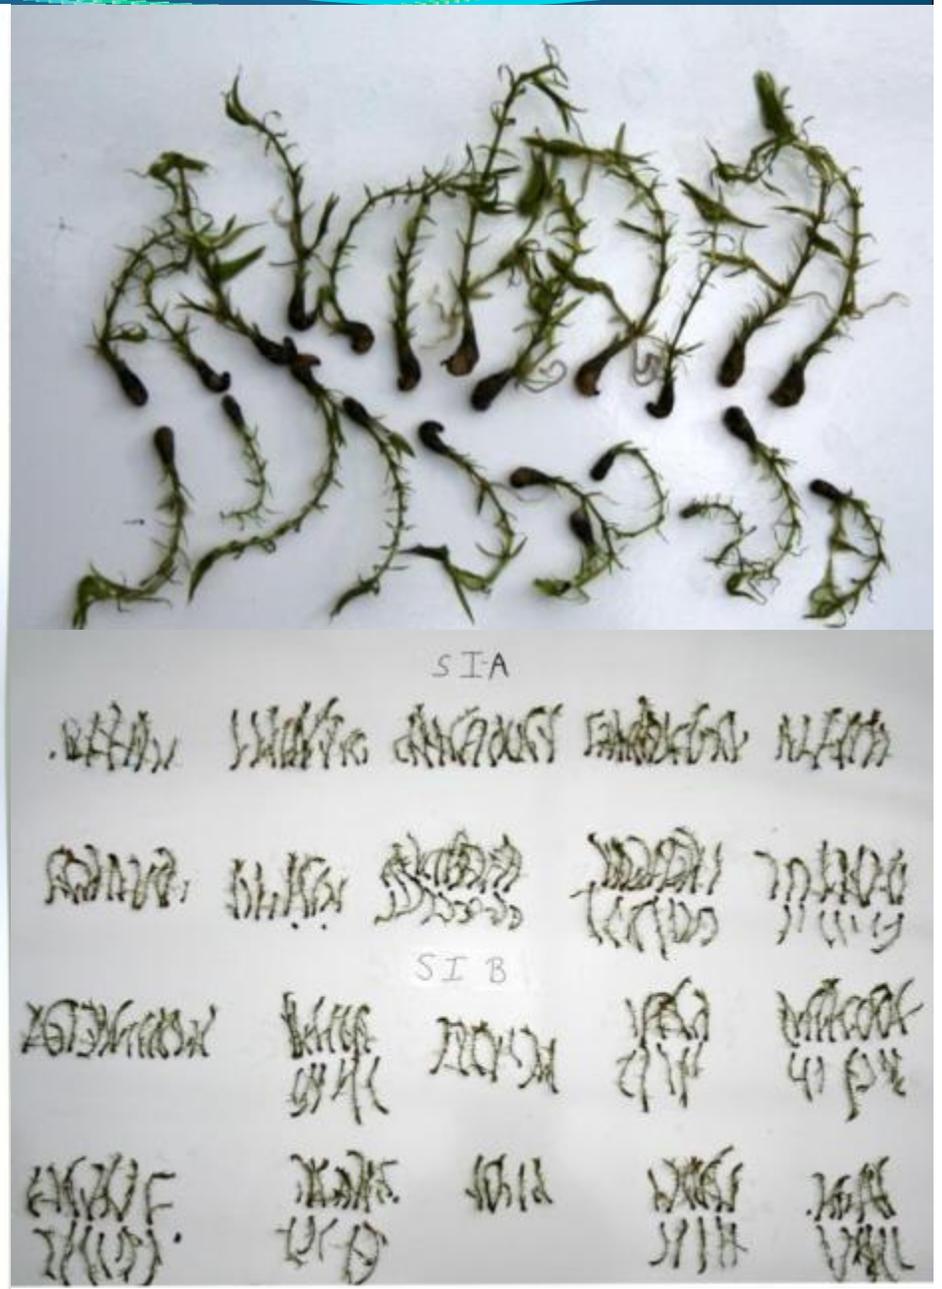
# Tubers in South Inlet at High Density

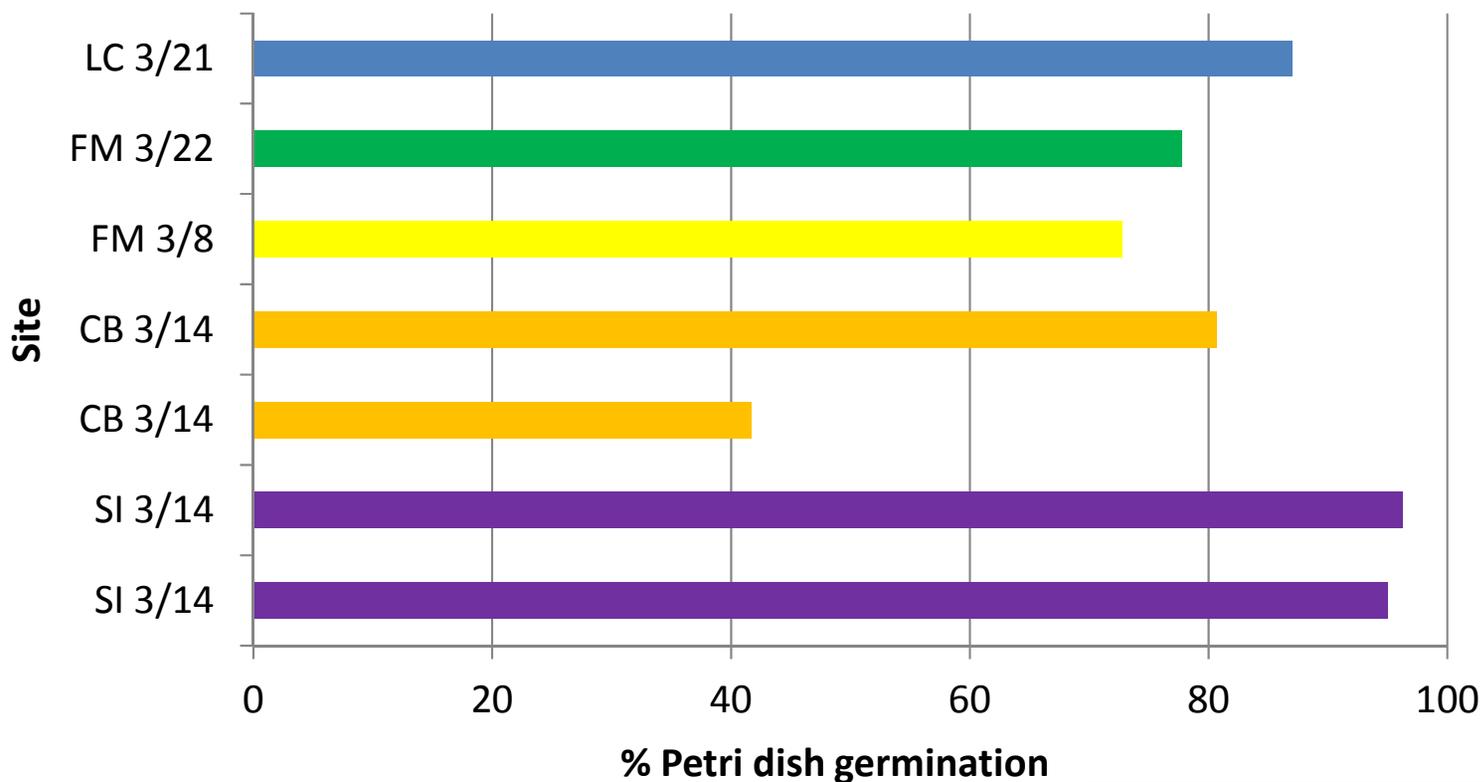
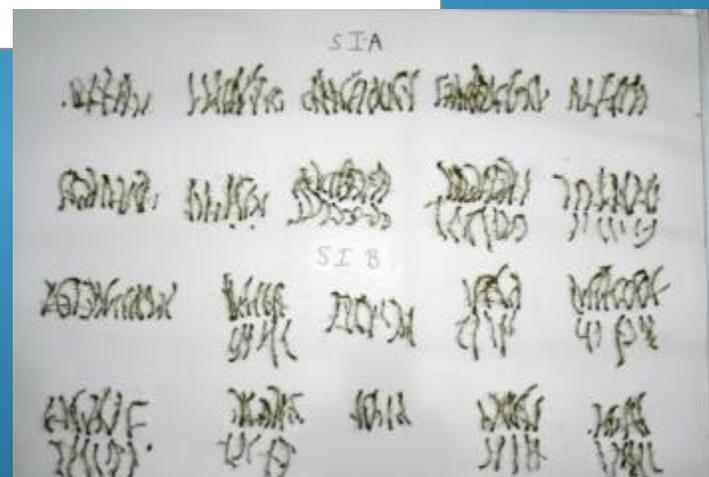
## % Petri dish germination of tubers per site

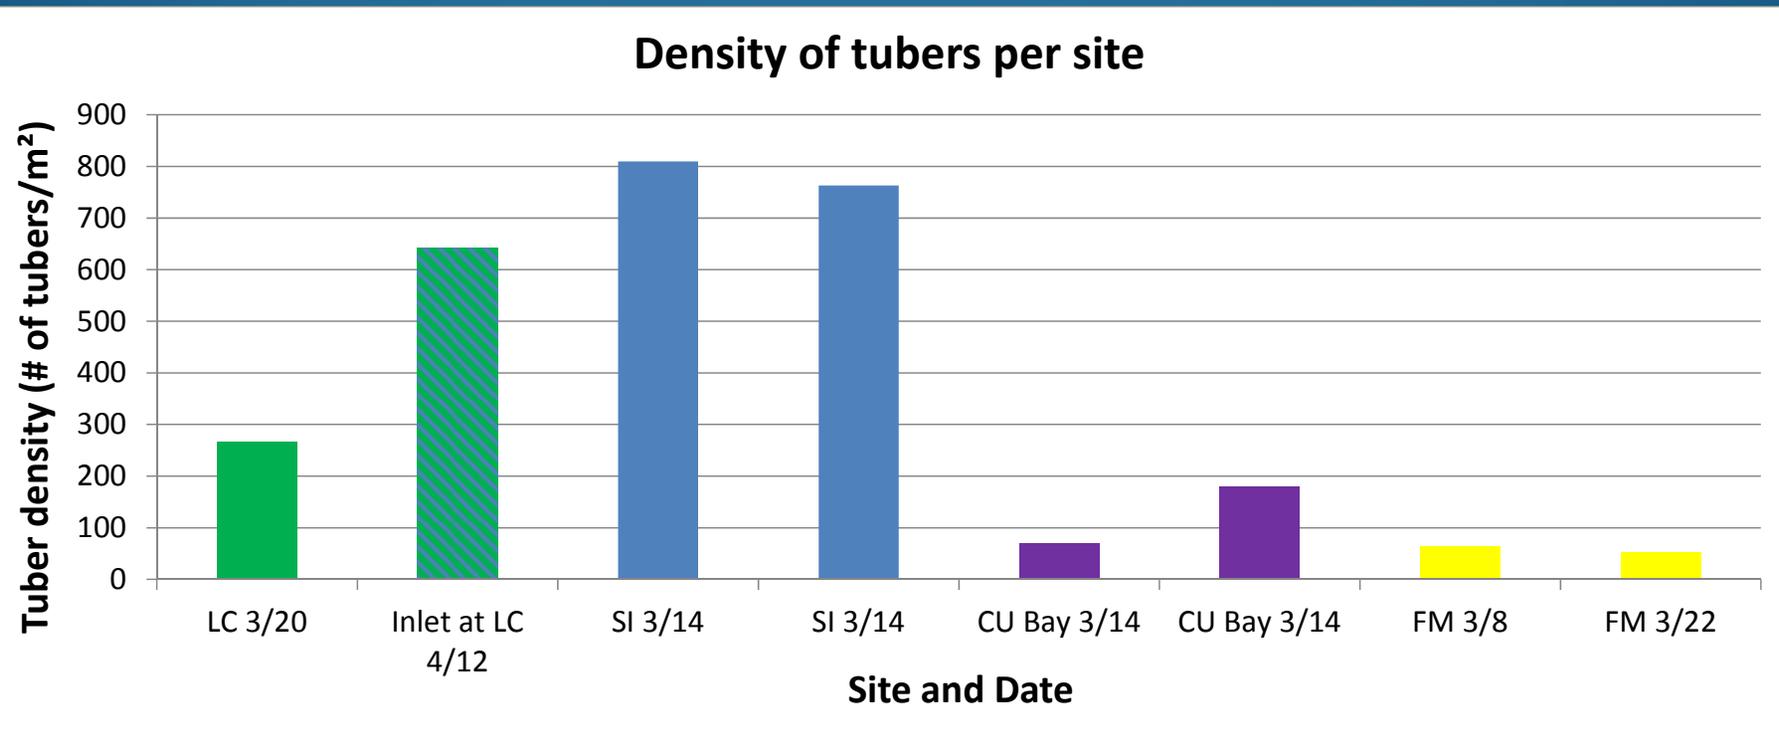
# Spring tuber density at locations

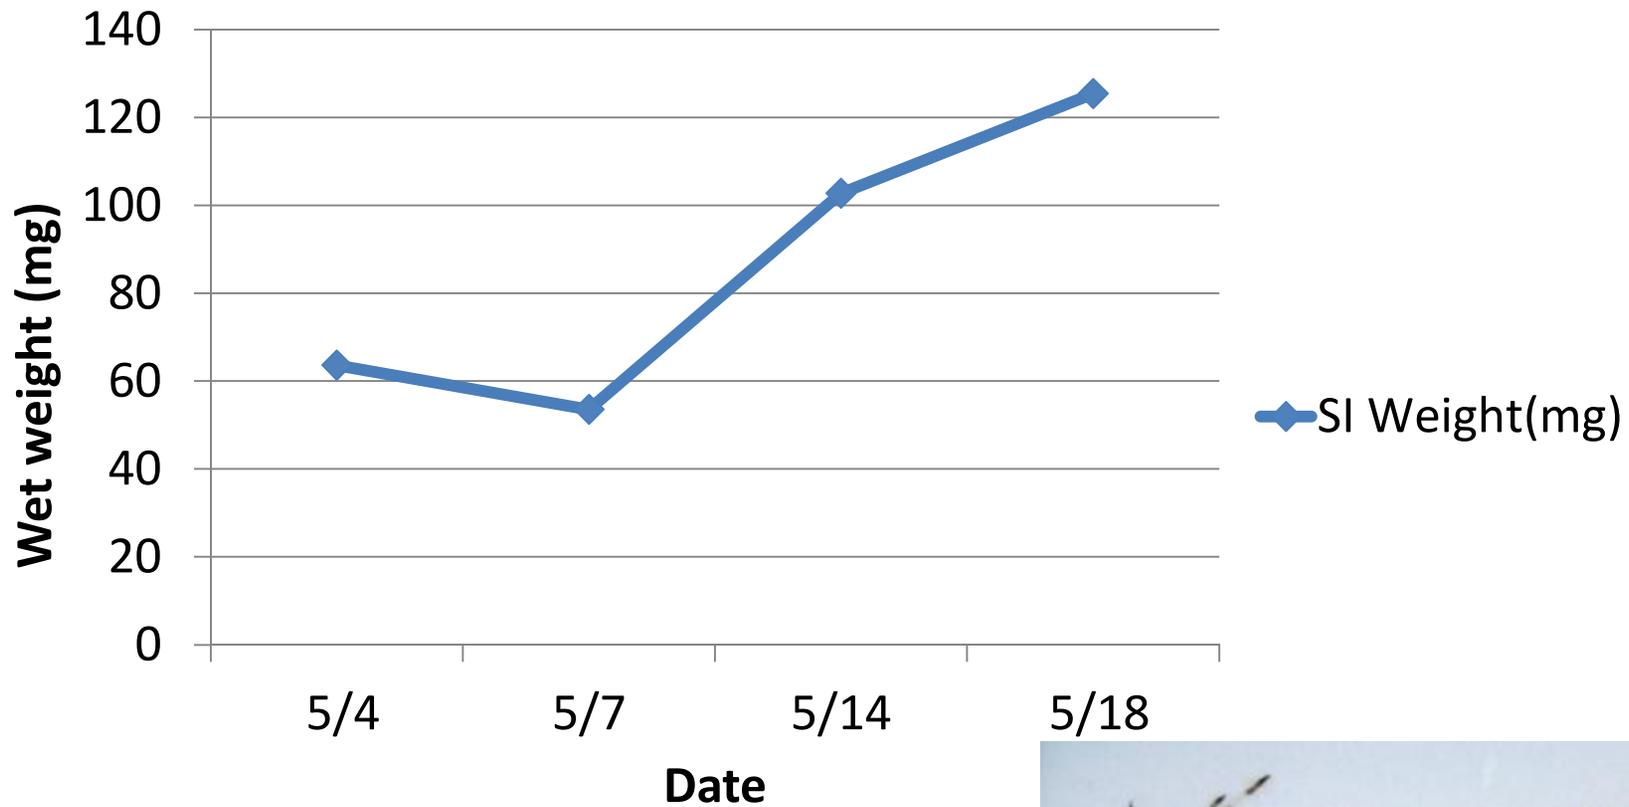
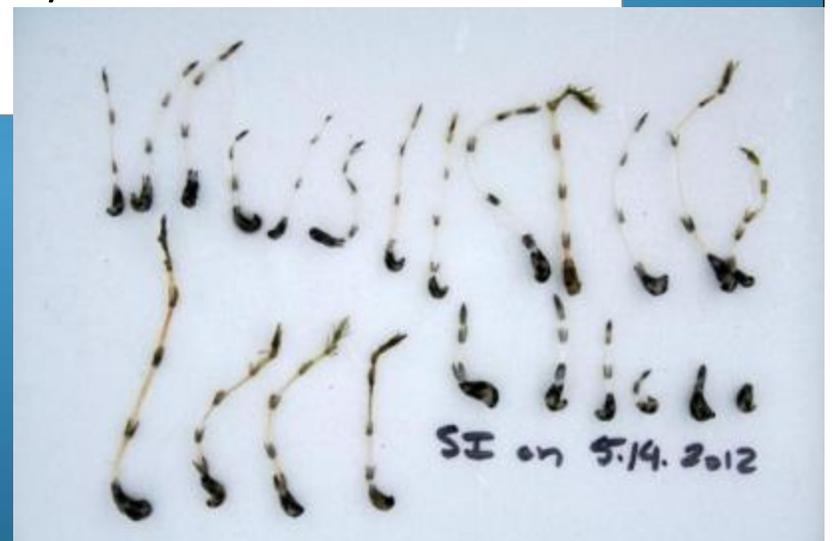
## Average wet weight (mg) of tubers over time

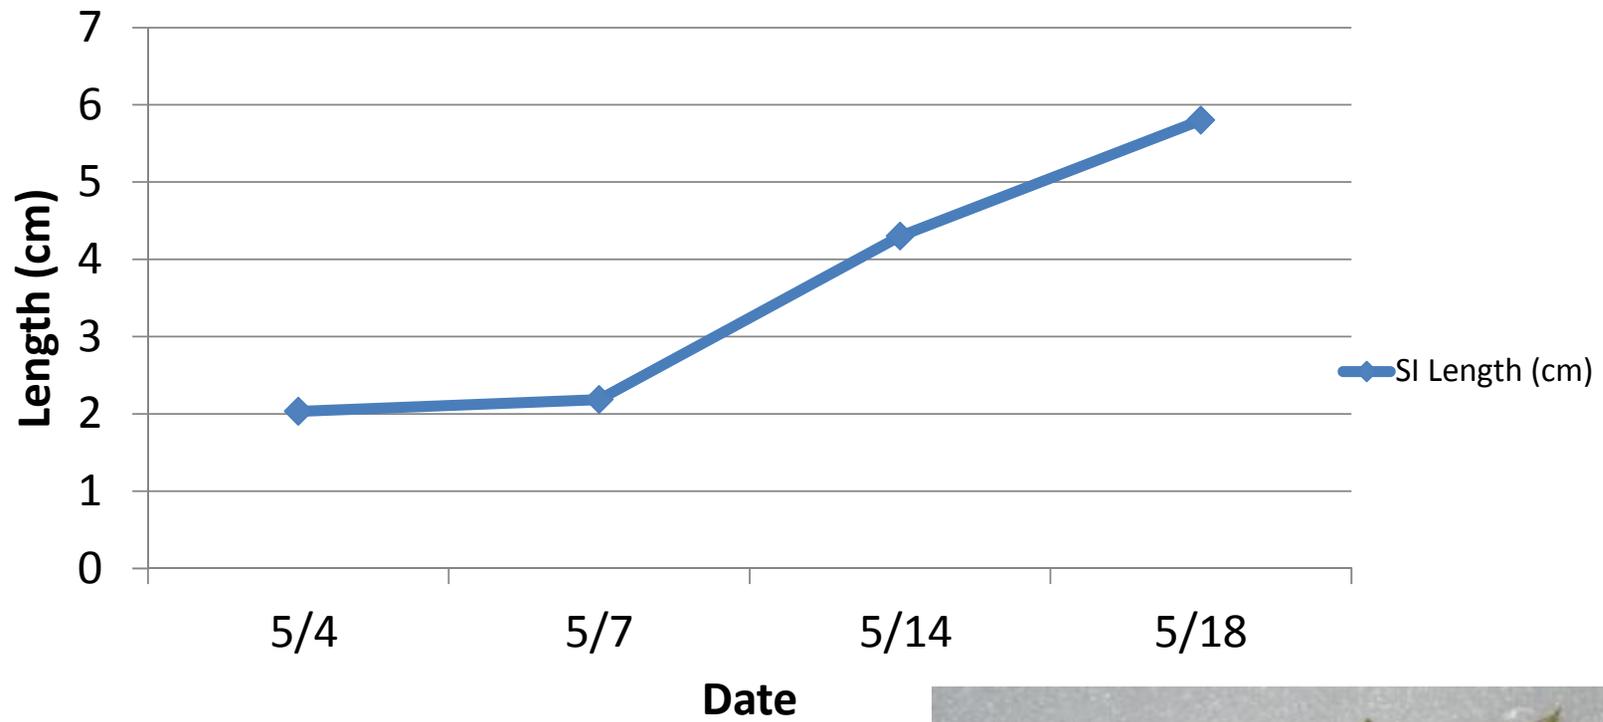
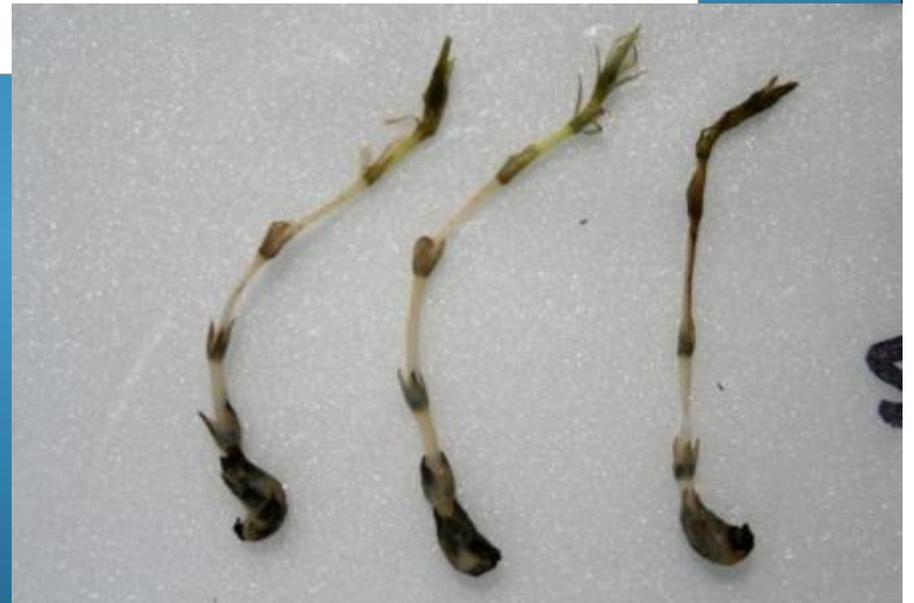
## Average length (cm) of tubers over time

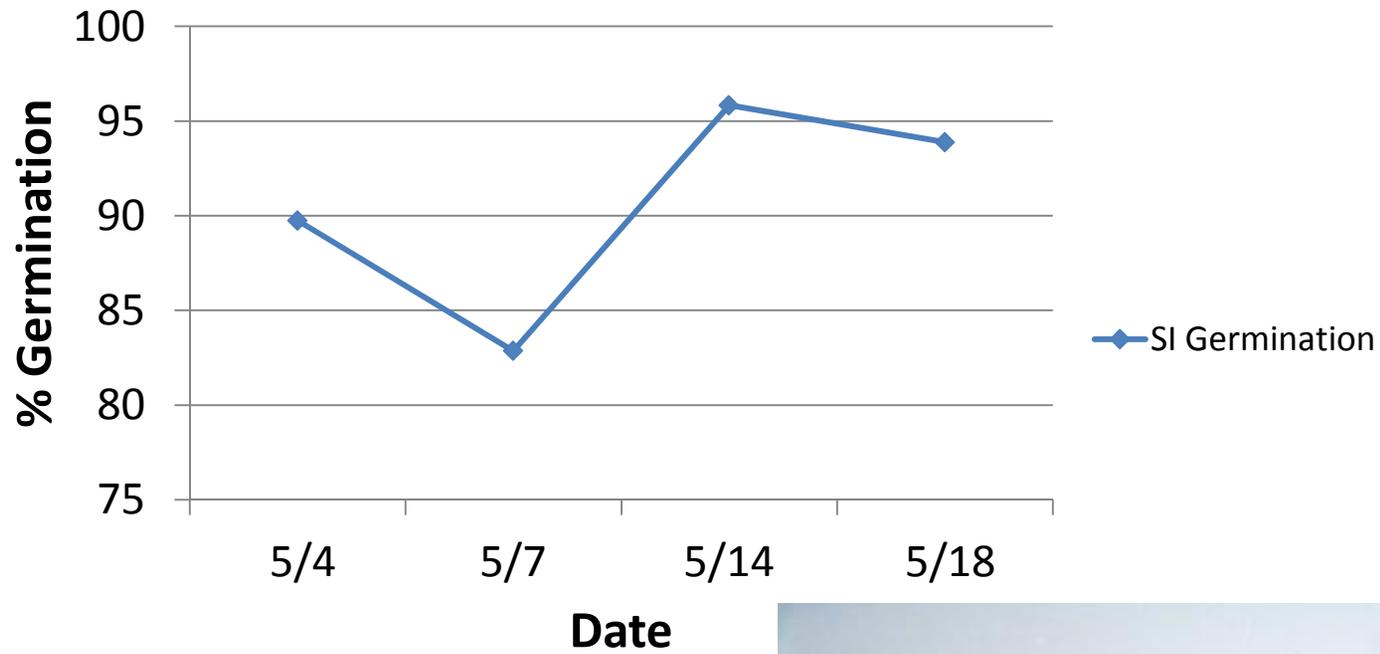
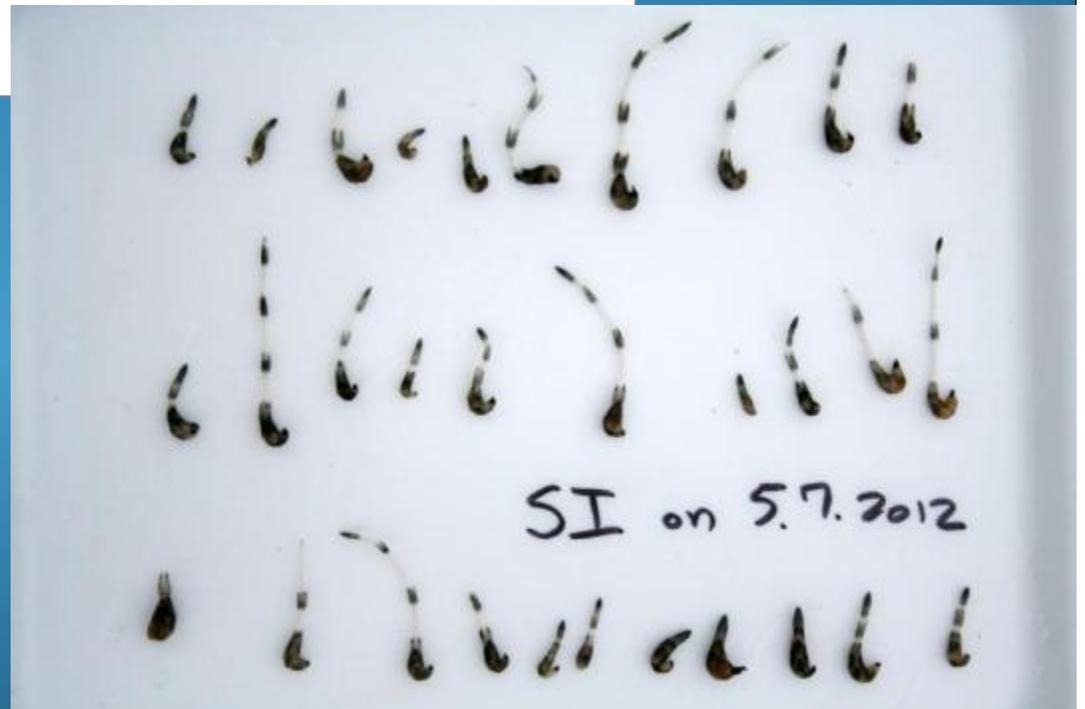
## South Inlet % Germination

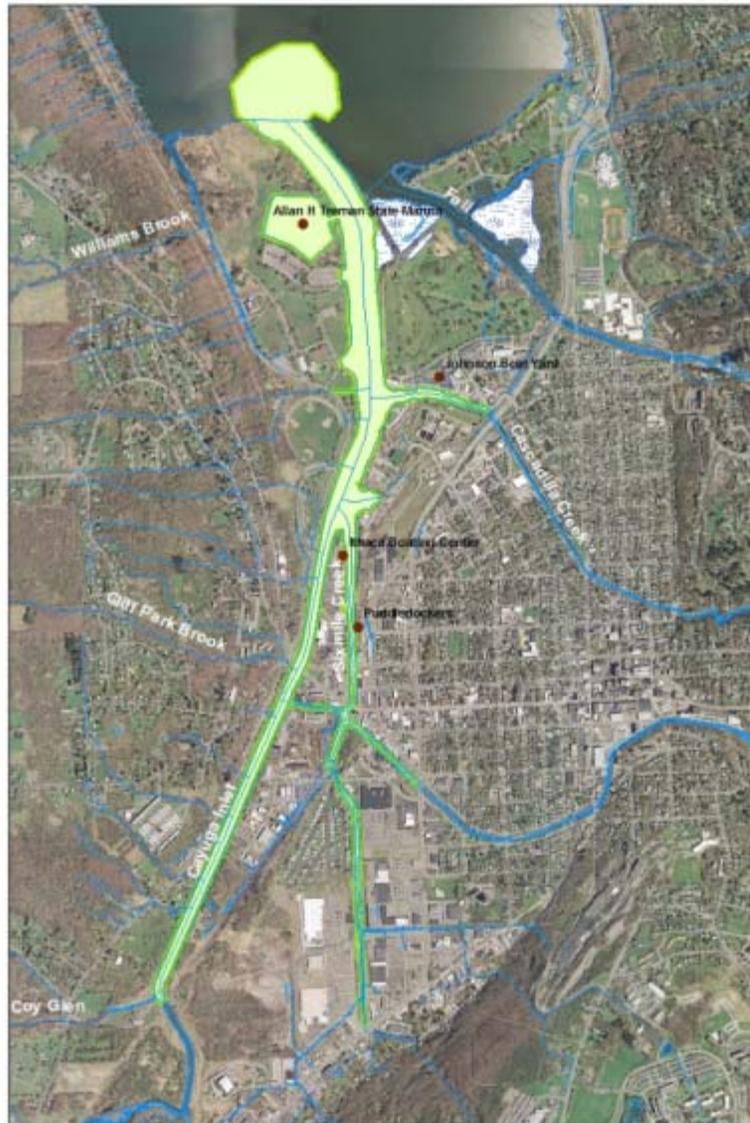
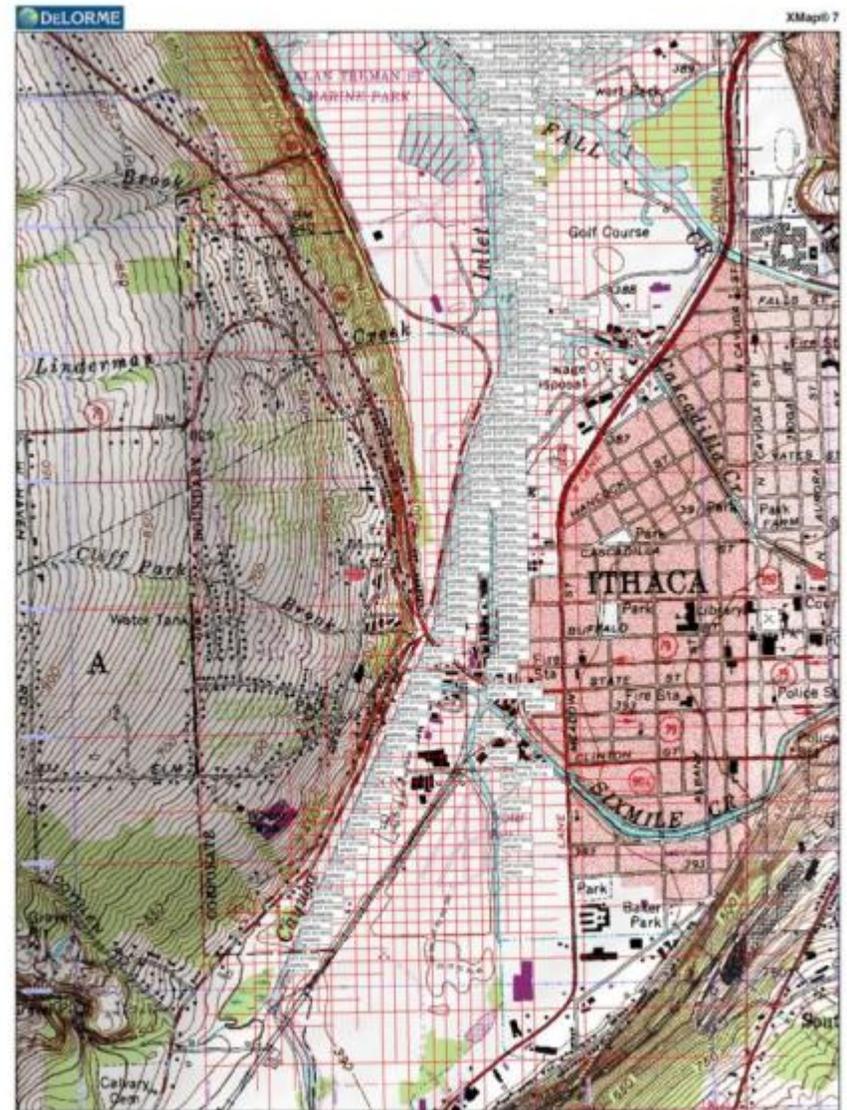
Cayuga Inlet Treatment Area 2012

# Treatment and Monitoring Area

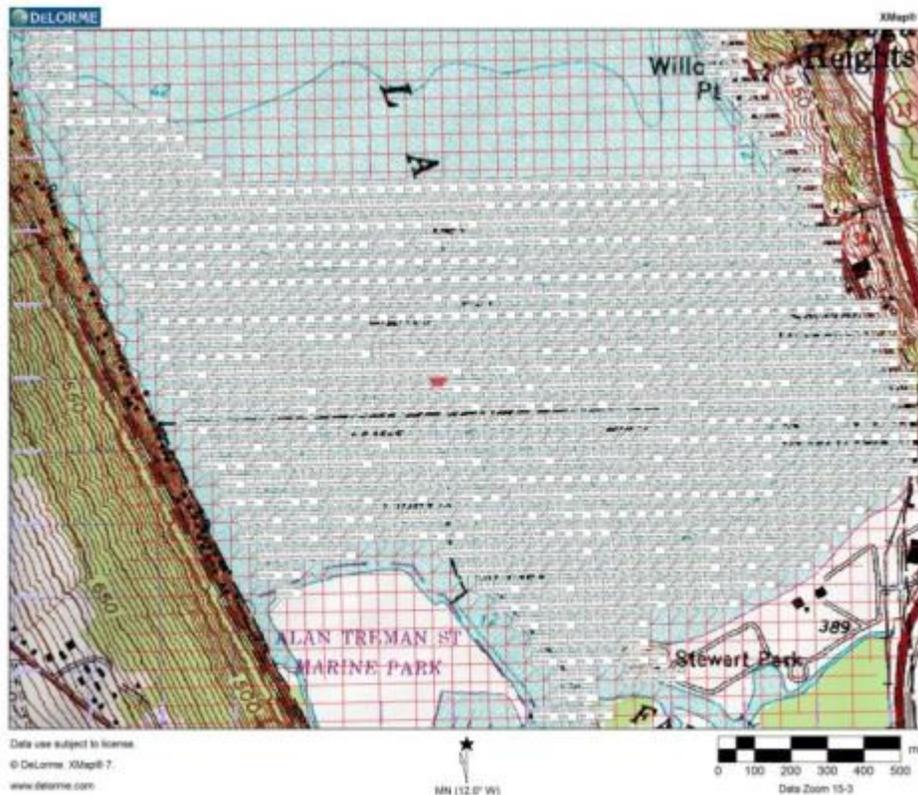
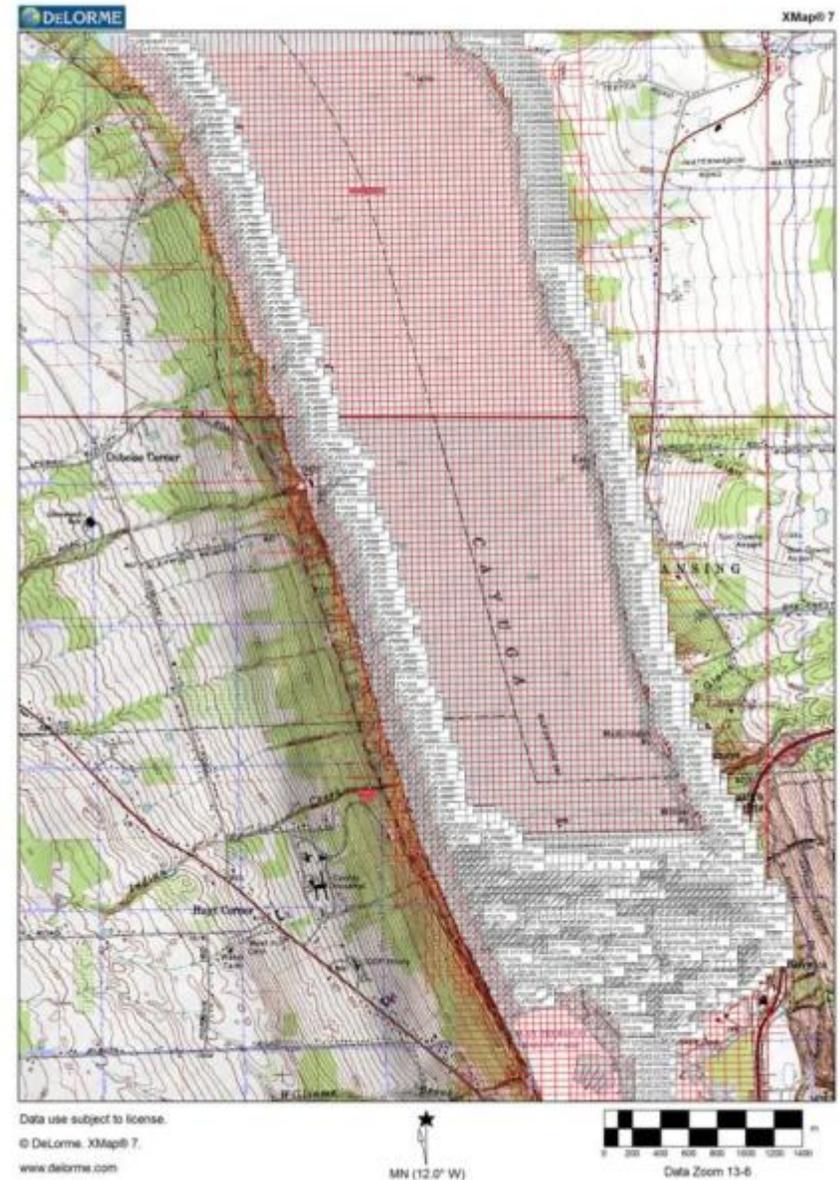
# Likely Sampling Points for South End of Cayuga Lake by Rake-toss and Divers On UTM 50X50m Grid

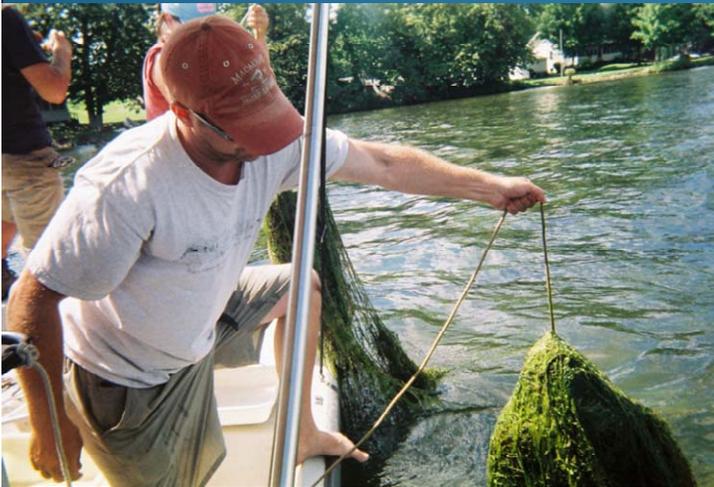
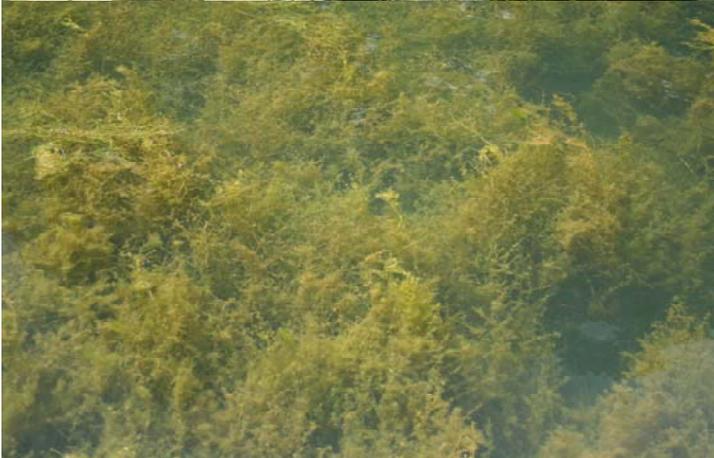
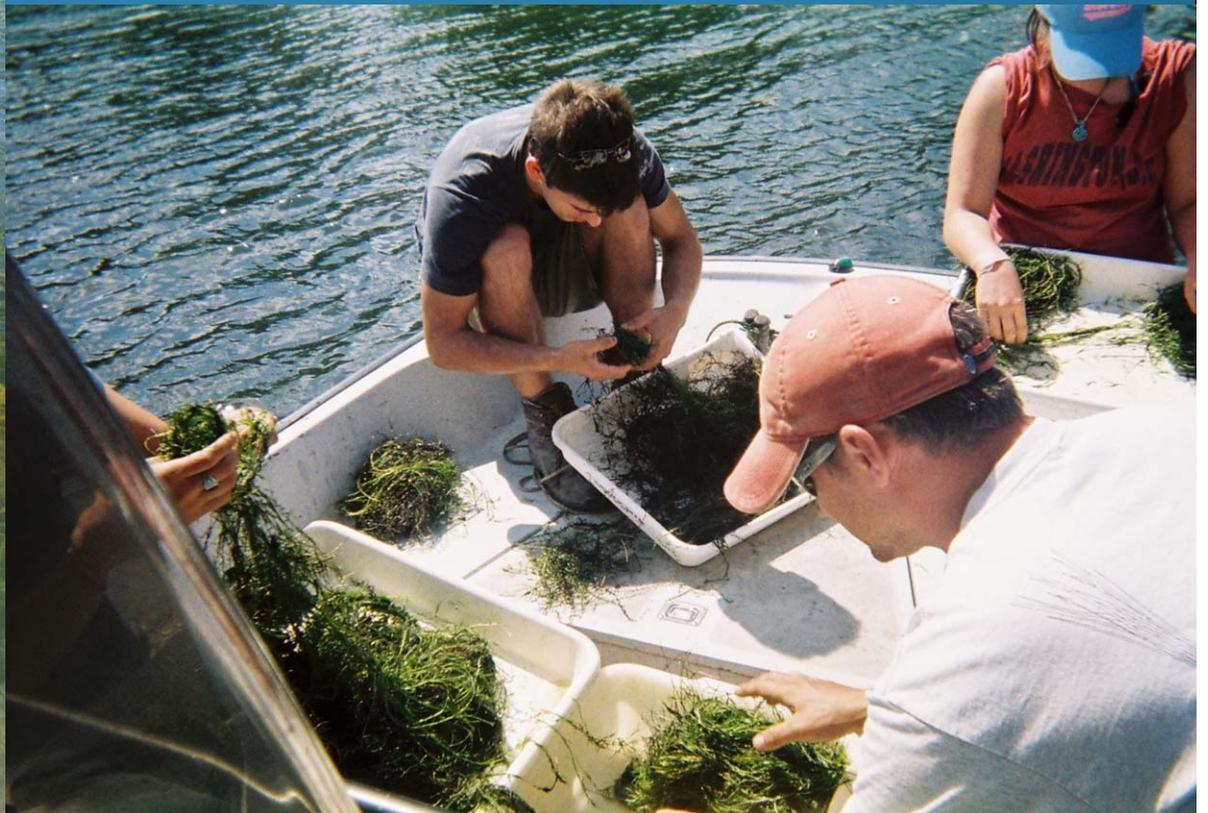
# Rake-toss plant survey on up to 1500+ locations on UTM Coordinate Grid
