Delineating and Monitoring Hydrilla in the New Croton Reservoir

By Chris Doyle, CLM
Director of Biology

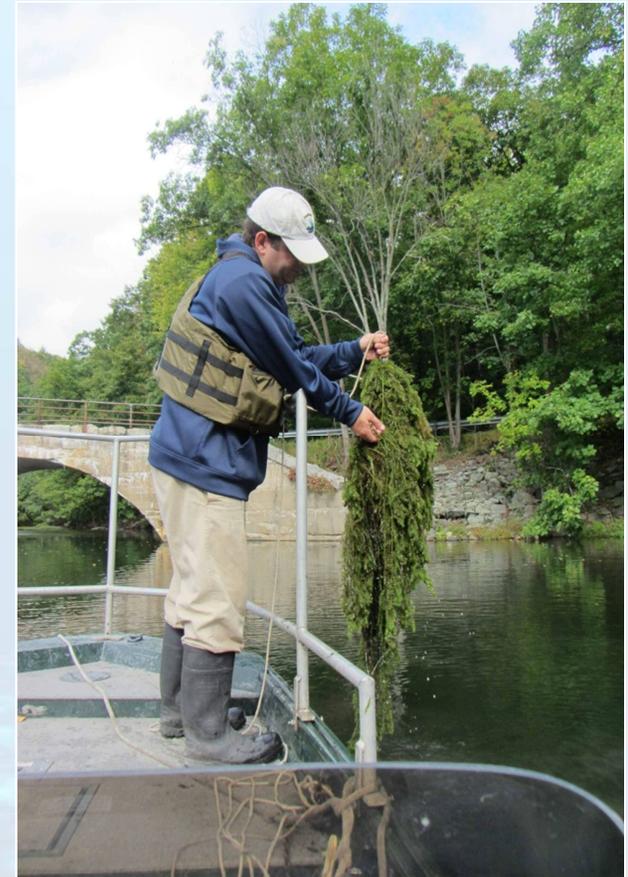
Three Phase Approach to 2016 Hydrilla Monitoring

1. Aquatic Plant Bio-volume Mapping

Hydroacoustic mapping

Assumed Littoral Zone

2. PIM Aquatic Plant Mapping

On select areas from Phase 1

Coves and Shorelines

3. Tuber Monitoring

Stations Selected from

Phase 2 Results

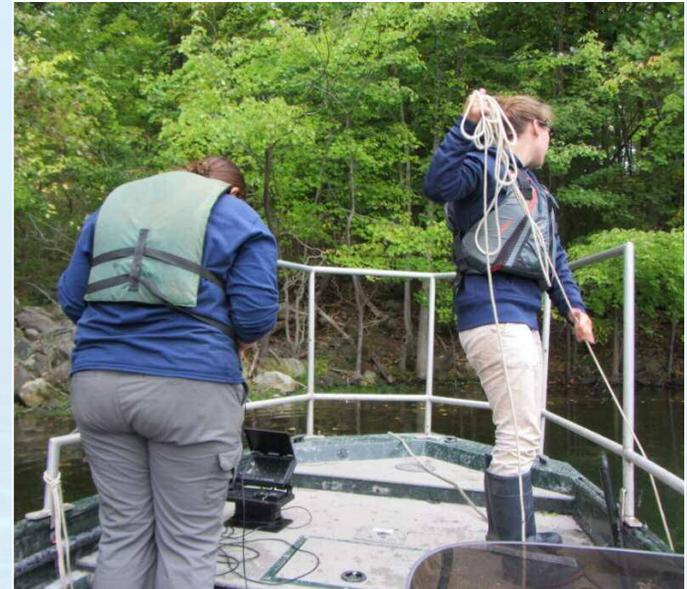
Phase 1: Hydroacoustic Plant Mapping

1. Side Scan Fathometer

2. Data Collection

- Late August
- Boat Speed: < 8 mph
- Shorelines, coves and littoral zone
- 18 hours on water data collection
- 20-minute runs (file size)

3. Data Outputs

- Uploaded to Manufacturer Server (QC/Interpolation)
- Reprocessed with Spatial Analyst
- ArcMap 10.3
- Bathymetry and Bio-volume Maps

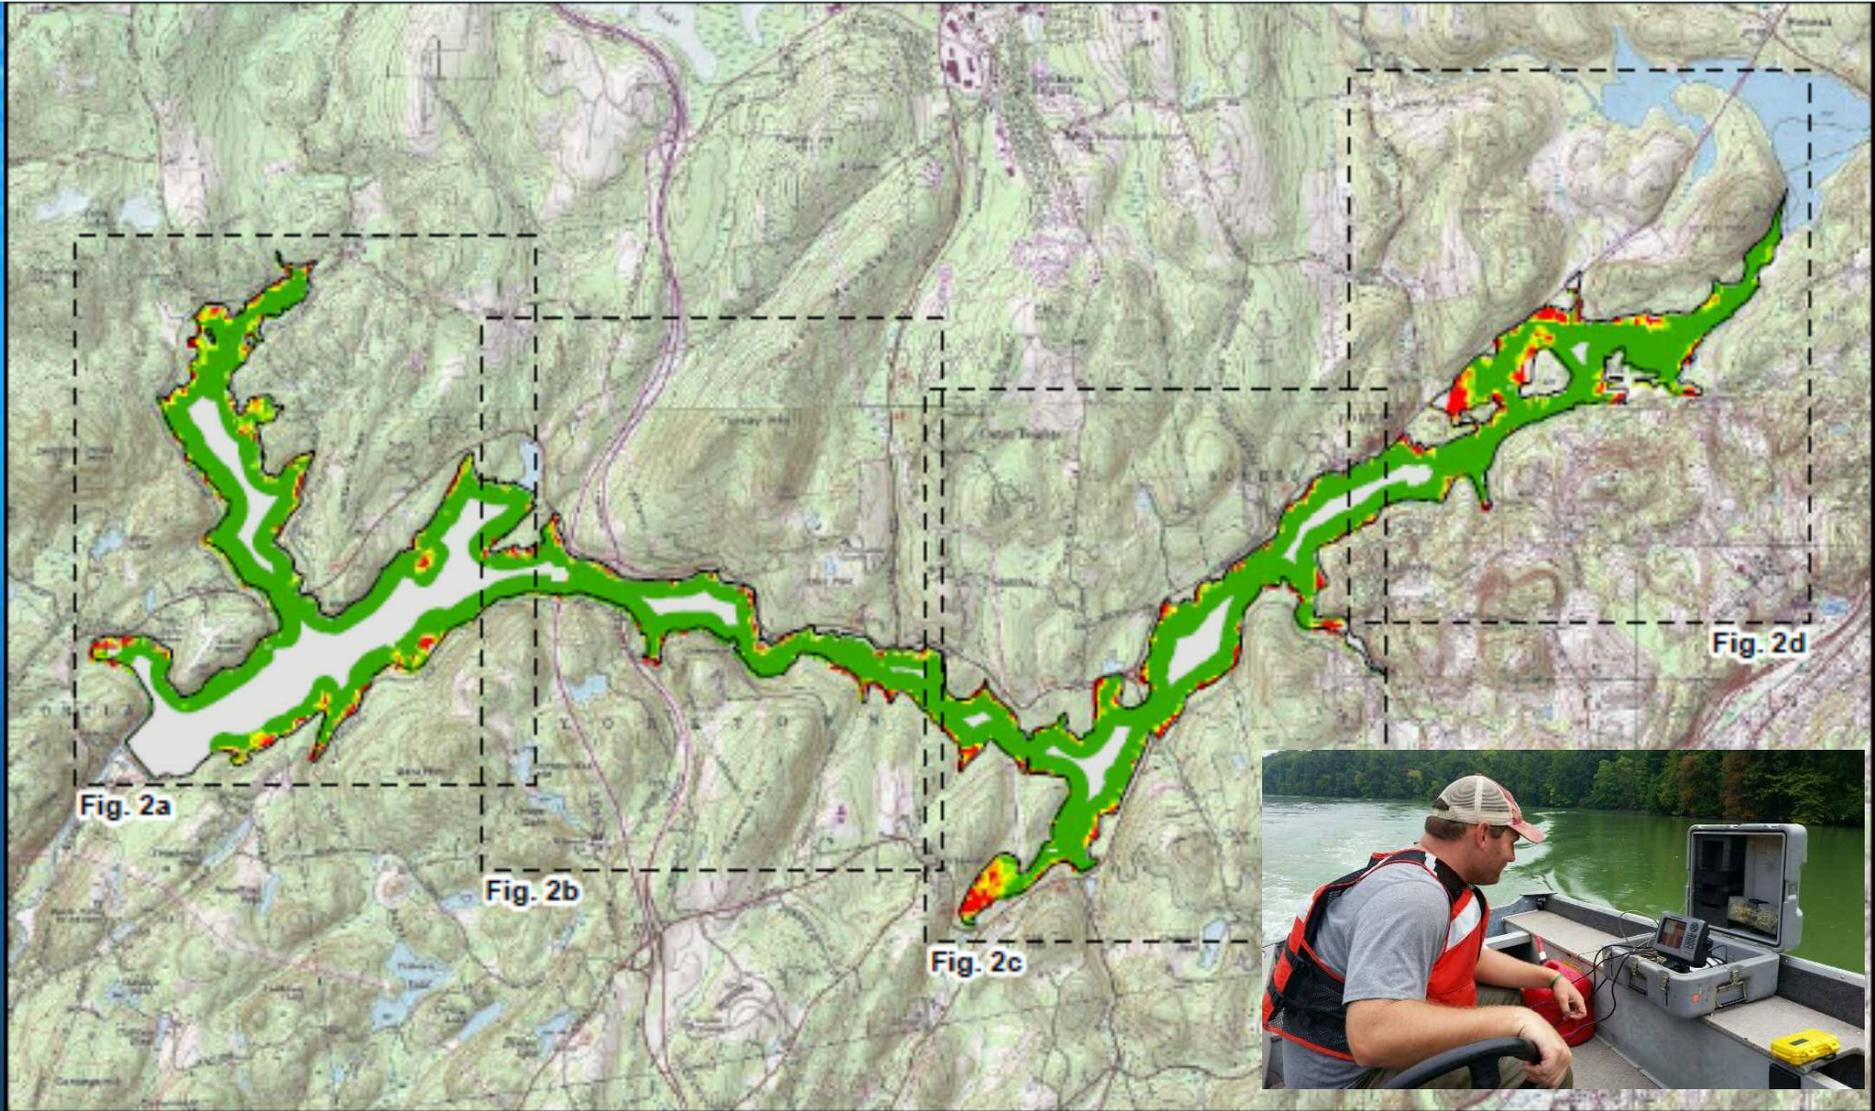
FIGURE:	SURVEY DATE:	MAP DATE:
2	8/30-9/1/16	11/30/16

Submersed Aquatic Plant Bio-volume

1. % of SAV in Water Column

- Ex. Plants at Surface = 100%
- Ex. Water Depth 10 ft.; Plant Height 5 ft. = 50%

New Croton Reservoir
Westchester County, NY

Biovolume

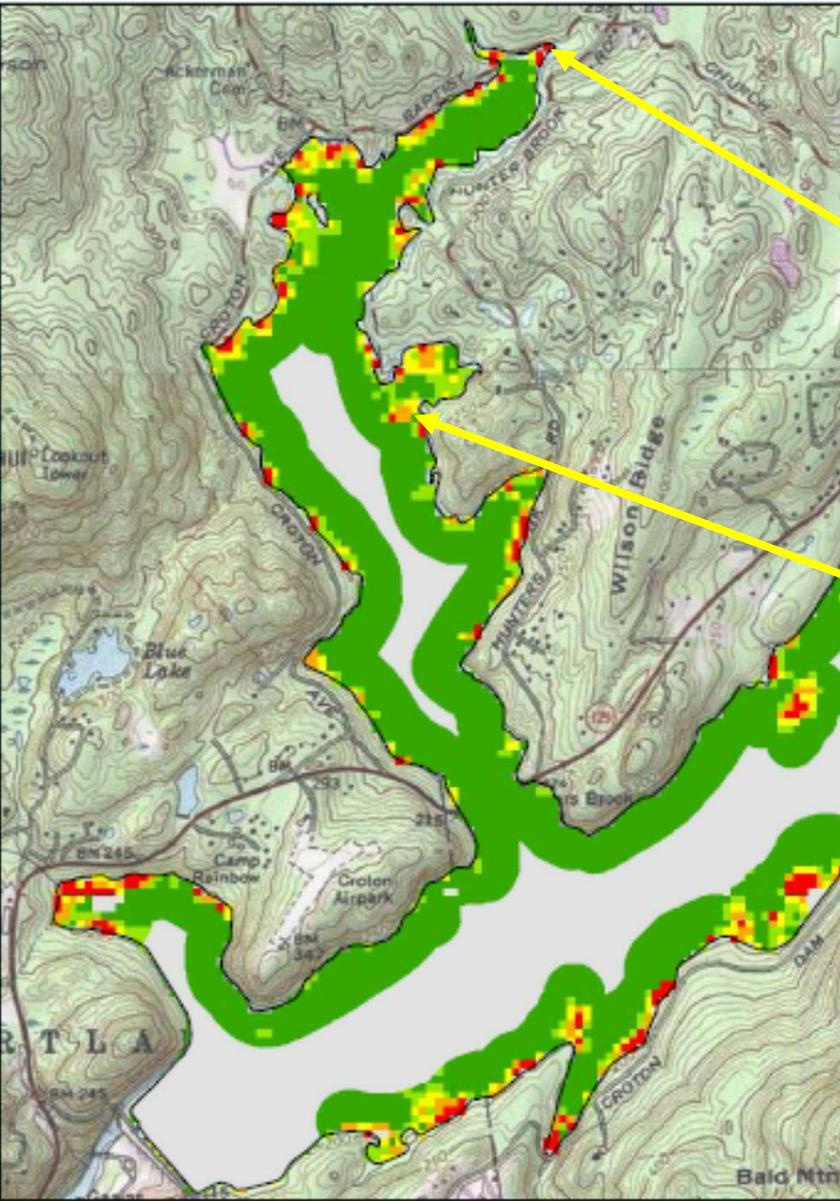
FILE#	SURVEY DATE	MAP DATE
74	10/16/11	11/19/11

New Croton Reservoir
 Westchester County, NY

Biovolume

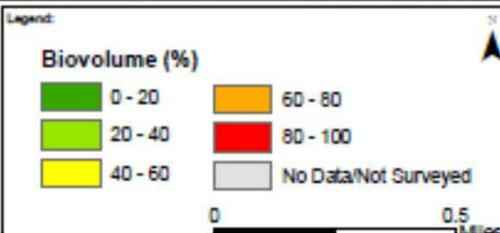
New Croton Reservoir- SECTION 1
 Aquatic Veg Survey 2016

50 m grid

Approx 92 points

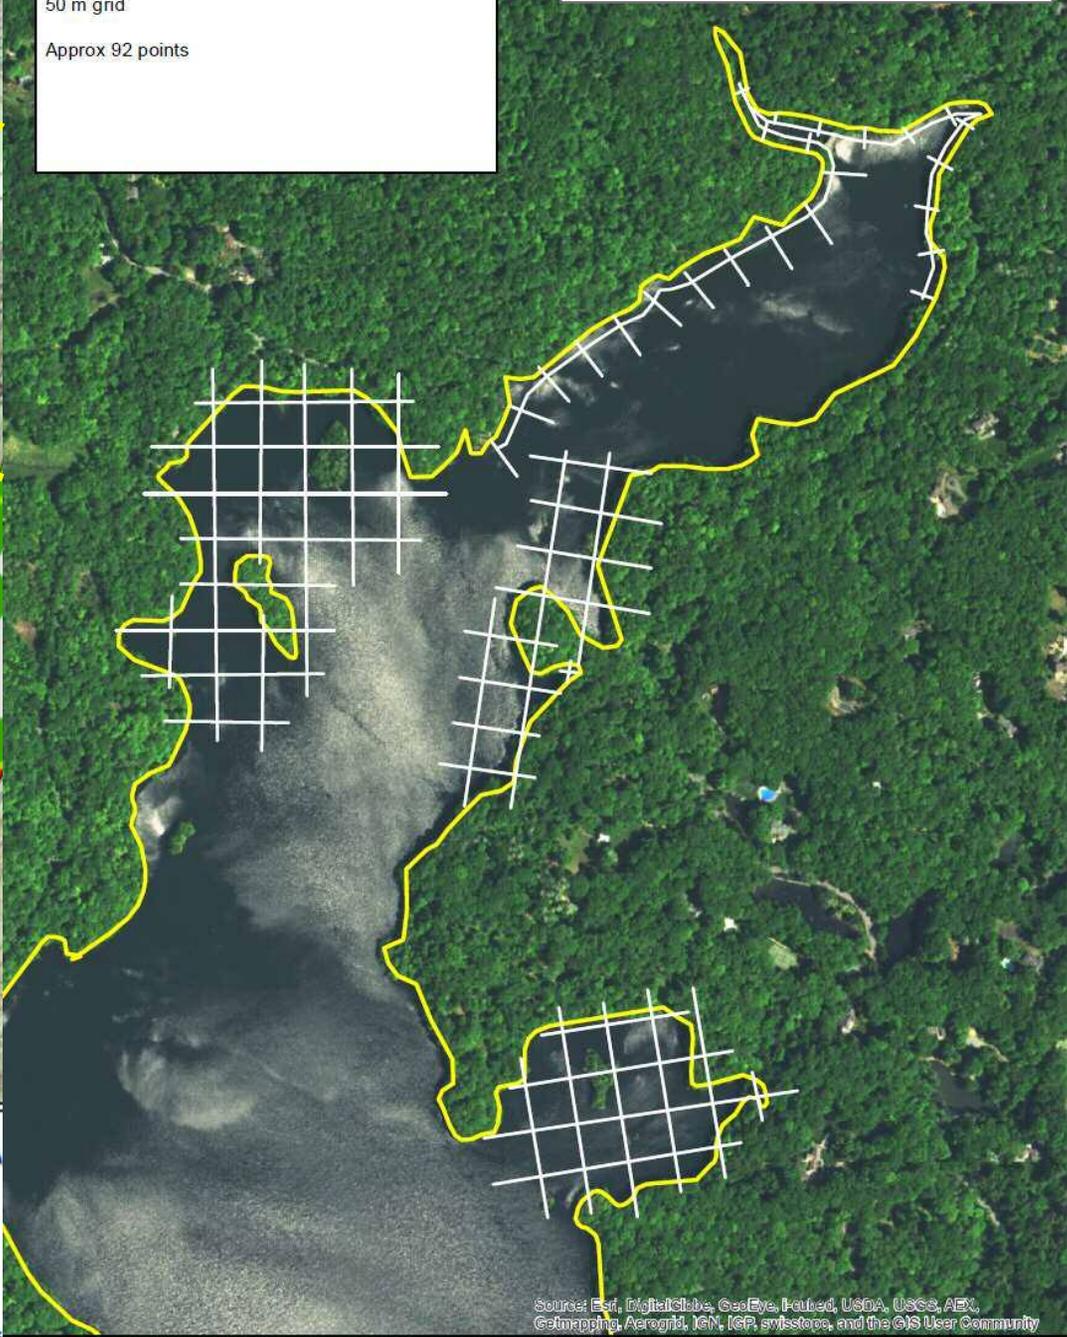
New Croton Reservoir- Overview
Aquatic Veg Survey 2016

Sections 1-9

50 meters grid

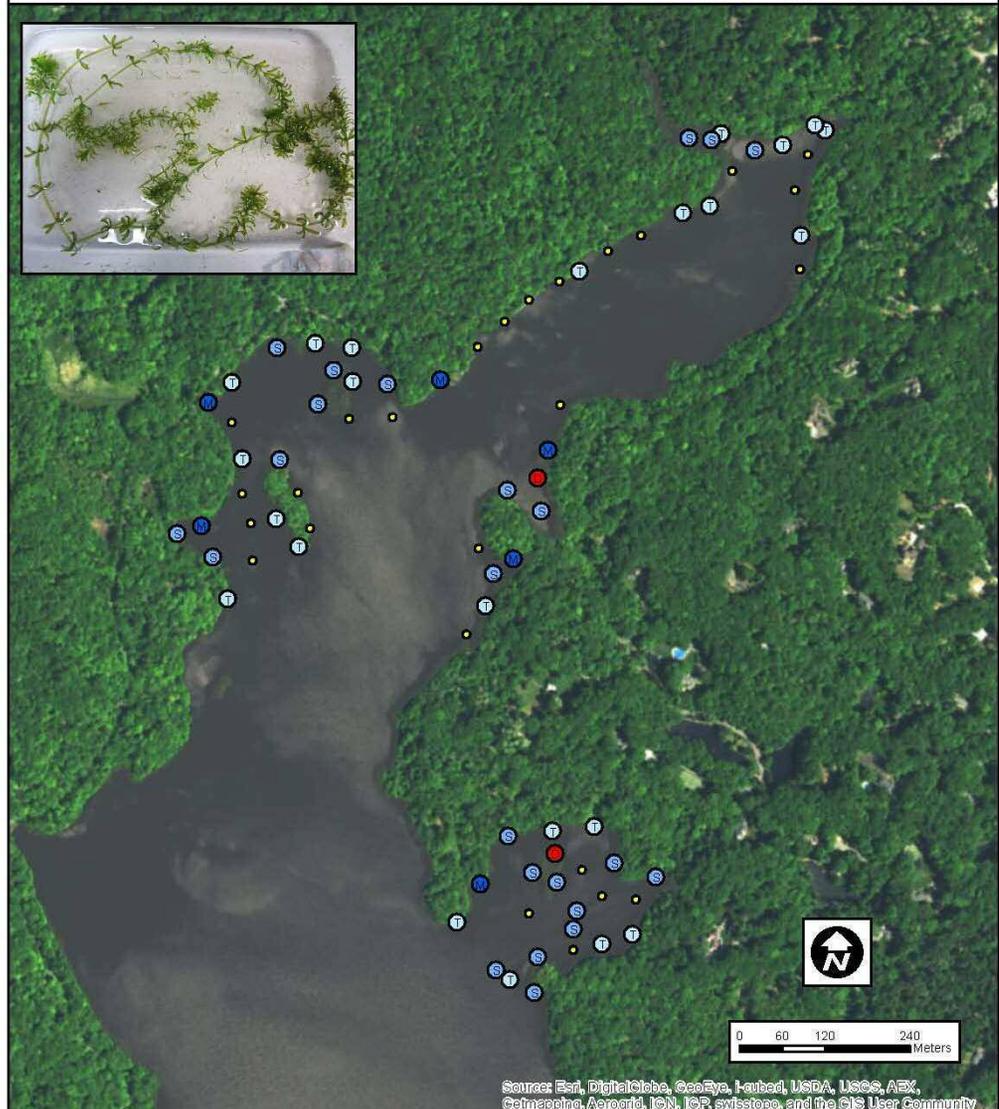
New Croton Reservoir
Section 1

Aquatic Vegetation Survey
September 28, 2016
80 Sites

Abundance	Sites	Percent
Total	54	68%
Trace	23	43%
Sparse	23	43%
Medium	6	11%
Dense	2	4%

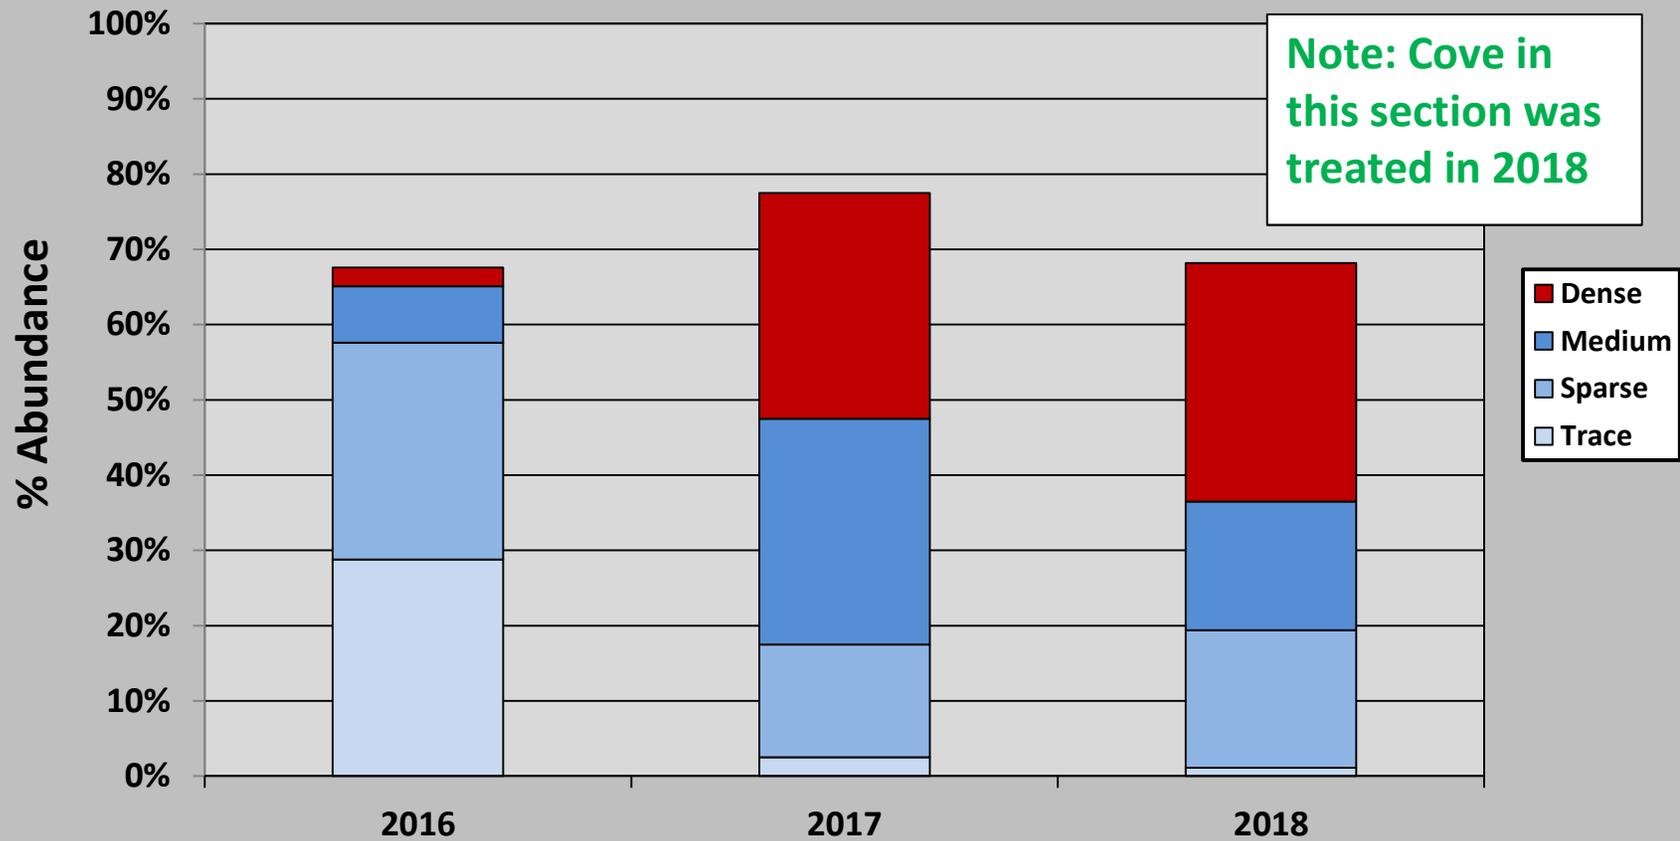
Hydrilla (*Hydrilla verticillata*)
Percent Abundance 2016/2017/2018
New Croton Reservoir
Section 1

n = 82

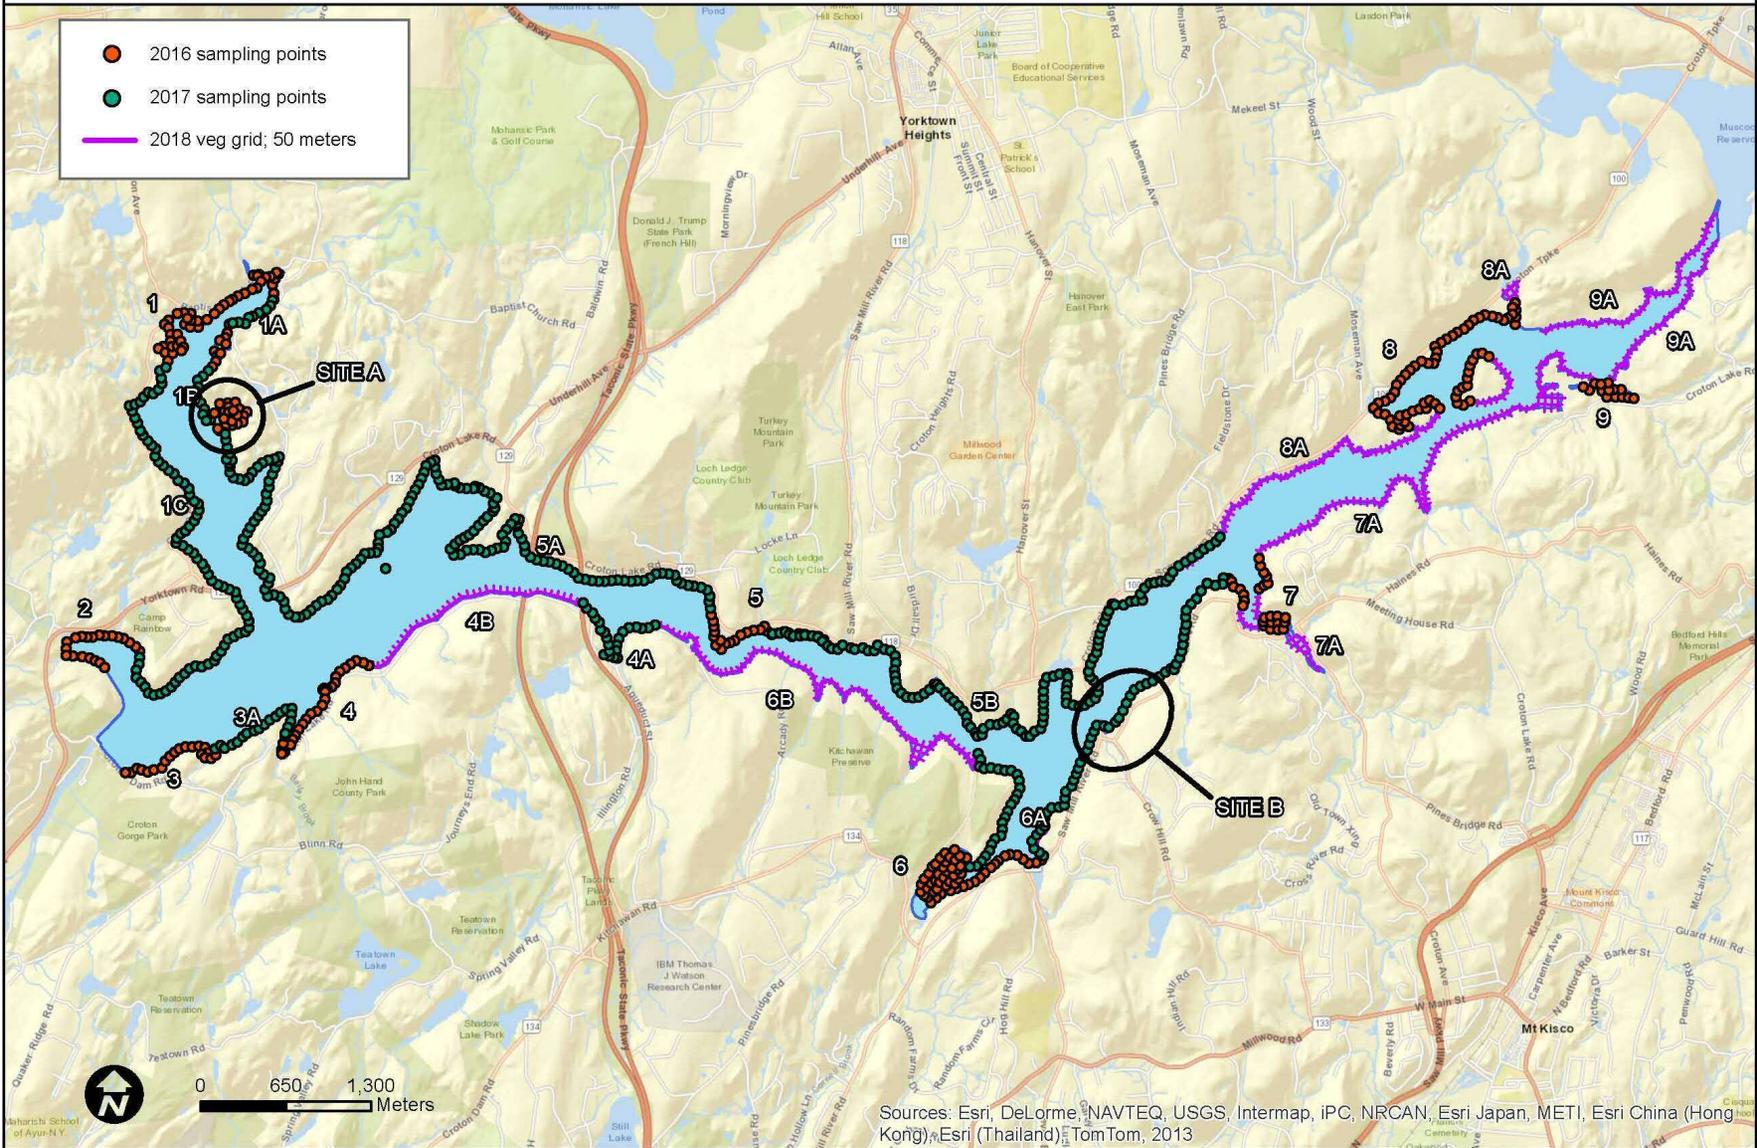
- 2016: 9 Sections (Red)
- 2017: Added 6 Sections (Green)
- 2018: Entire Littoral Zone (Purple)

New Croton Reservoir Aquatic Vegetation Survey 2016-2018

- 2016 sampling points
- 2017 sampling points
- 2018 veg grid; 50 meters
